MAJOR DEFECTS AND DIAGNOSTICS OF SOLID INSULATION OF POWER TRANSFORMERS

A. P. Dolin¹ and M. M. Kipriyanova²

Translated from *Élektricheskie Stantsii*, No. 6, June 2022, pp. 27 – 33. DOI: 10.34831/EP.2022.1091.6.004

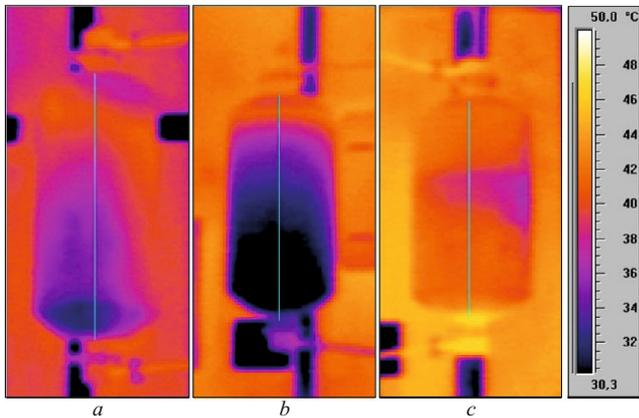
The thermographic inspection of adsorption and dehydrating filters represents the most effective control over the possible carryover of silica gel (Fig. 1). The underfilling of a filter may indicate the improper replacement of silica gel or its loss, followed by possible ingress into the active part of the transformer.

Fig. 1. Thermograms of adsorbers: *a*, fresh silica gel is filled; *b*, initial stage of sludging and contamination of silica gel; *c*, silica gel is underfilled.

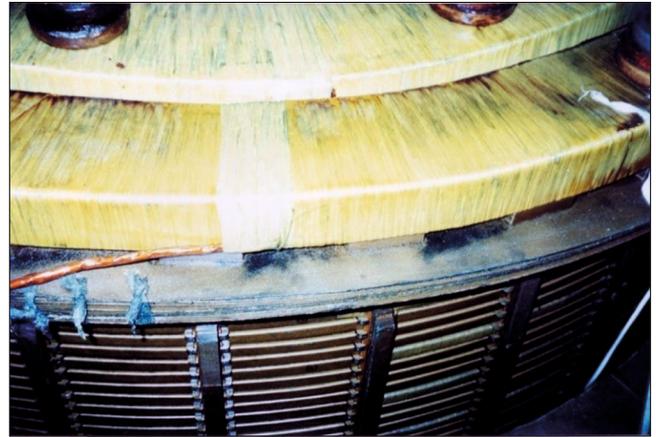
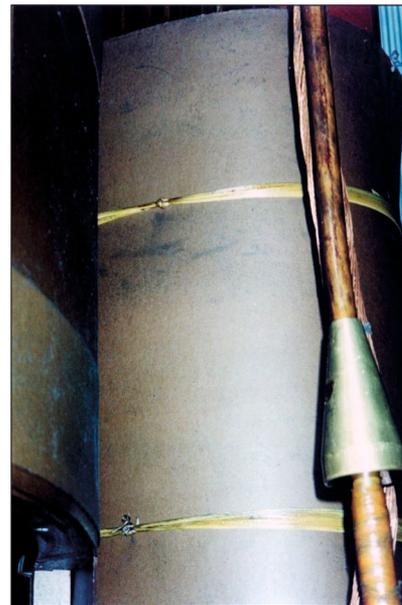
When short-circuits or other defects occurring in the magnetic system of transformers are accompanied by spark discharges, the decomposition of oil results in contamination of the active part with carbon (Fig. 2). Subsequently, the gradual accumulation of acetylene dissolved in oil can be observed, whose concentration often reaches or exceeds the limit value of 10 ppm or 0.001%. The level of contamination depends on the power of the spark discharge and the duration of the defect development. It is possible to identify the contamination of the active part with carbon by variations in the dissipation factor ($\tan \delta$) of the oil (at 90°C). For example, HC-grade hydrocracking oil obtained from the transformer tank (Fig. 2) exhibited $\tan \delta = 0.8\%$ on the day of sampling, with a subsequent decrease to 0.15% on the next day (following sedimentation).

Fig. 2. Carbon contamination of solid insulation of TDTs-250000/500 transformer at a developed defect of magnetic system.

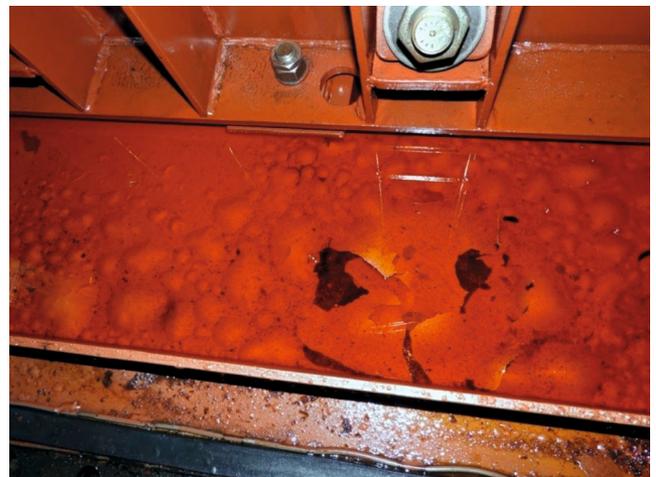
Less commonly, the active part can be contaminated with peeling paint from the inner surface of the tank (Fig. 3) or oil pipes in some designs of foreign transformers [3]. Analyses have shown that the paint used for this purpose may contain

materials based on metal salts (usually iron), whose accumulation in large quantities leads to a decrease in insulation characteristics, as well as transformer failures [3].

Fig. 3. Bottom of TRDNS-40000/35-74U1 transformer tank having paint defects.

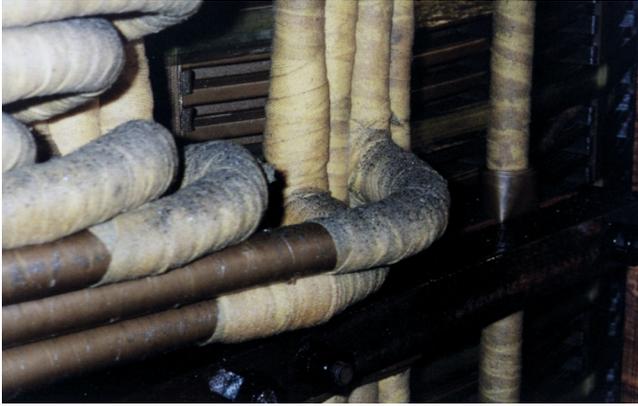
Severe damage to the insulation can be caused by contamination with metal shavings (Fig. 4) resulting from the failure of oil pump bearings in transformers with forced oil circulation, especially in the absence or destruction of the plate filter.

It should be noted that when the insulation is contaminated with materials having high conductivity (especially metal shavings), the insulation resistance R_{60} significantly decreases, while the dissipation factor $\tan \delta$ increases to a lesser extent. For example, in a TRDTsN-80000/110 U1 transformer (Fig. 4), the resistance decreased by 5 – 6 times (Fig. 5), while $\tan \delta$ increased only by 1.5 – 2 times, being less or equal to 0.37% at 20°C for the measurement scheme HV-G+LVI+LV2. Here, the low moisture content (0.6 – 1.1%) in solid insulation affected the insulation characteristics insignificantly.

Fig. 4. Contamination with metal dust of lead-outs of TRDTsN-80000/110 U1 transformer windings.

Timely detection of such defects is most effective through periodic vibration monitoring of oil pumps, using equipment and software based on analysis of spectral-amplitude characteristics measured at various sections (in the bearing area and “snail”).

The removal of metal shavings, carbon, and fine silica gel from the insulating surfaces of transformers during overhaul repairs has proved difficult and inefficient. For instance, for a transformer shown in Fig. 4, following the removal of shavings using a directed flow of oil, the active part was washed and dried using the oil circulation and spraying under a vacuum. The resulting insulation resistance increased by 2 times at 20°C (up to values of 600 – 930 MΩ in different zones), while the dissipation factor was reduced by 0.05 – 0.19%.

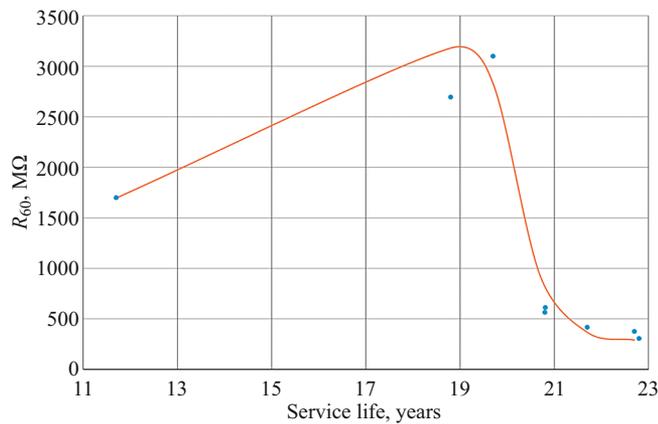
Fig. 5. Dynamics of R_{60} resistance (normalized to 20°C for HV-G+LV1+LV2 measurement scheme of a transformer (Fig. 4)).

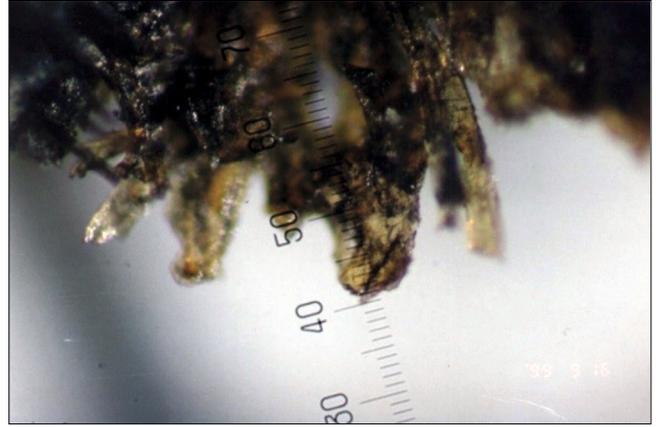
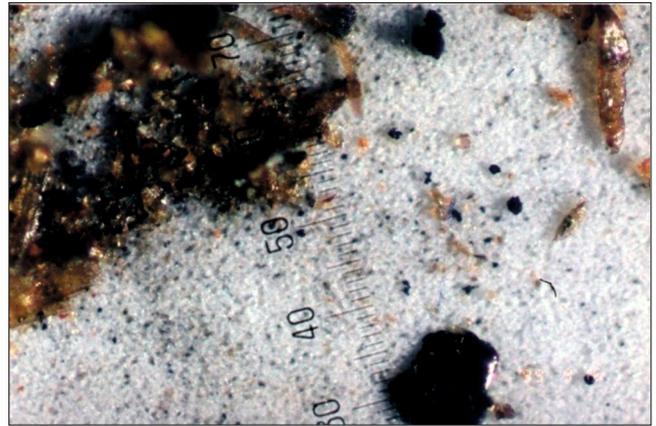
The aging and consequent oxidation of oil leads to the formation of sludge, whose deposition on the surface of solid insulation results in increased electrical conductance and the deterioration of the insulation characteristics of windings (Fig. 6).

Fig. 6. Characteristic areas of filter membranes contaminated with sludge samples at approximately 100× magnification.

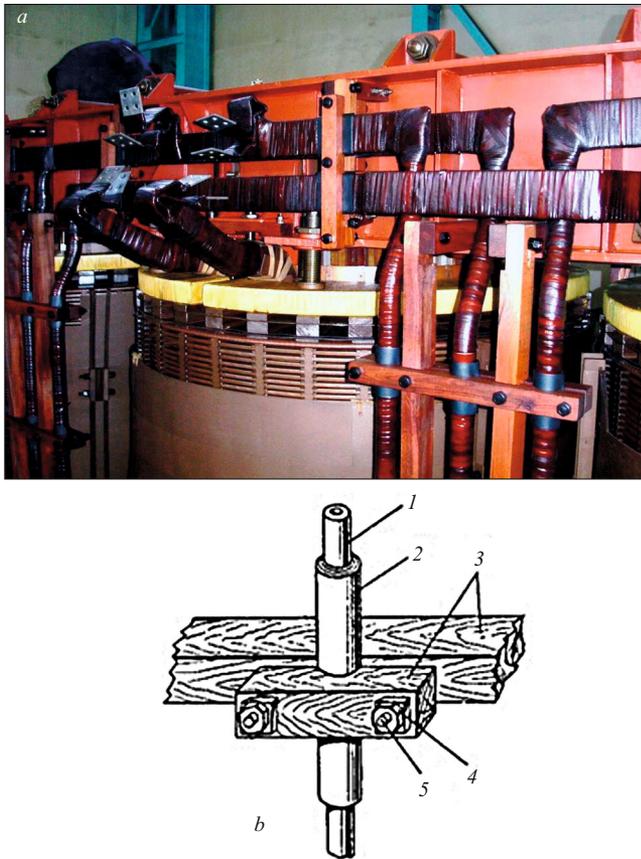
The results of direct measurements of the moisture content of solid insulation (3 mm thick insulating cylinders and barriers, a 0.5 mm thick winding selected at the attachment points of the leads-out) (Fig. 7) were as follows. Transformers having a D cooling system (natural oil circulation) are always characterized by higher moisture content in the cellulose insulation at the bottom of the tank, while transformers having a DC cooling system (forced oil circulation) show only a slight difference in moisture content values between the top and bottom of the tank. Figure 8 depicts the diagrams of the highest recorded moisture content in the selected samples collected from the upper (1) and lower (2) parts of several 110, 150, and 220 kV transformers equipped with D and DC cooling systems. In these diagrams, the conditional numbers of transformers are indicated along the x -axis.

Fig. 7. Attachment points of lead-outs: *a*, sampling area at the top of transformer; *b*, mounting structure; 1, insulating lead-out; 2, electrical cardboard insulation; 3, beech plates; 4, 5, textolite pin with nut.

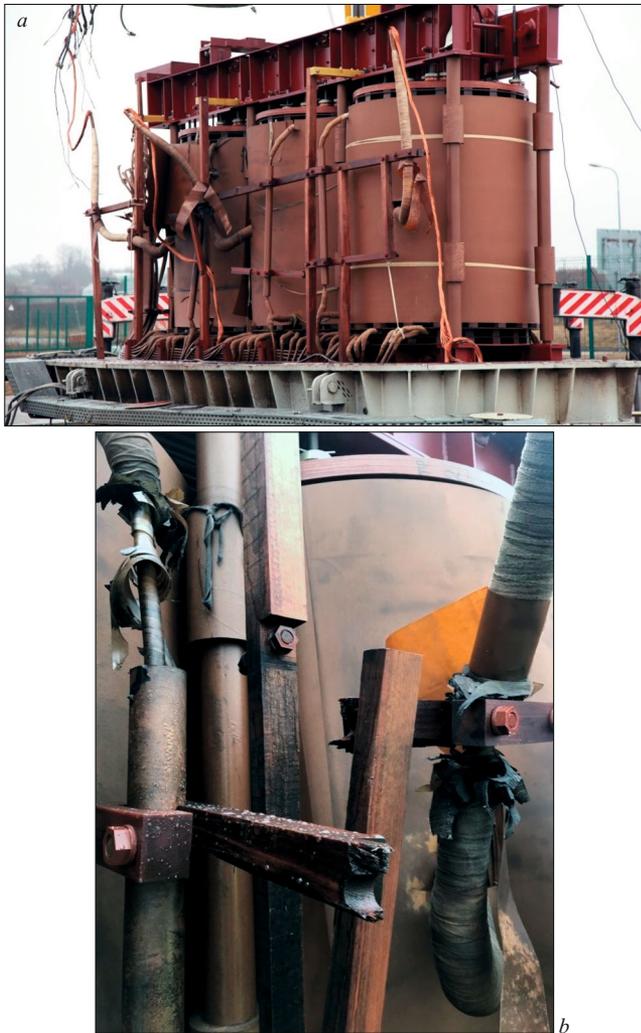
Fig. 10. The active part of TRDN-25000/220 U1 transformer (*a*) and damage to mounting rails of leads-out in arc burn zone (*b*).

Moisture accumulation in wooden spacers is another common cause of transformer failures. As an example, the results of an evaluation of the active part of the TRDN-25000/220 U1 transformer are shown in Fig. 10, where a flashover occurred along the horizontal and vertical wooden spacers from the attachment point of the high-voltage (HV) A-phase leading to the attachment point of the neutral lead. The moisturization of the wooden spacers might have been due to insufficient drying of the active part by the manufacturer or moisture ingress during the storage of the transformer. In addition, the failure of the transformer occurred due to exceeding the minimum permissible (calculated) distance along the horizontal spacer between the A-phase and neutral leads, as well as a defect in the lead attachment. Due to vibrations, the bolted connections of the leads in the wooden spacers were loosened, resulting in the displacement

of the leads and unwinding of the additional insulation of HV leads of the A-phase, as well as the C-phase (Fig. 10*a*).

Although the results of dissolved gas analysis (DGA) in the transformer tank oil performed less than 6 months prior to failure, as well as physical and chemical analyses of oil (including breakdown voltage and moisture content), indicated no development of discharge processes and general moistening of the active part, it was necessary to dry the active part and the oil prior to commissioning the transformer a year before its failure.

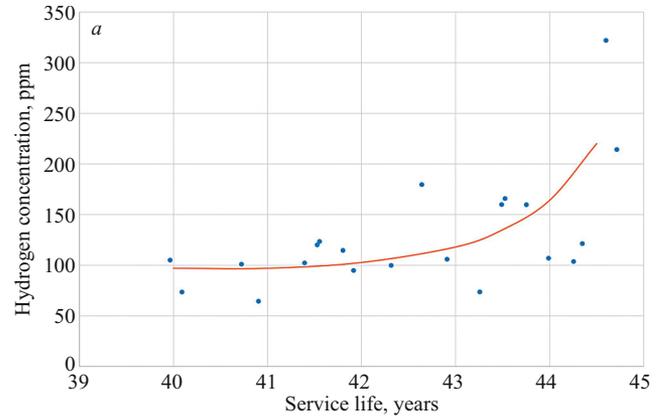
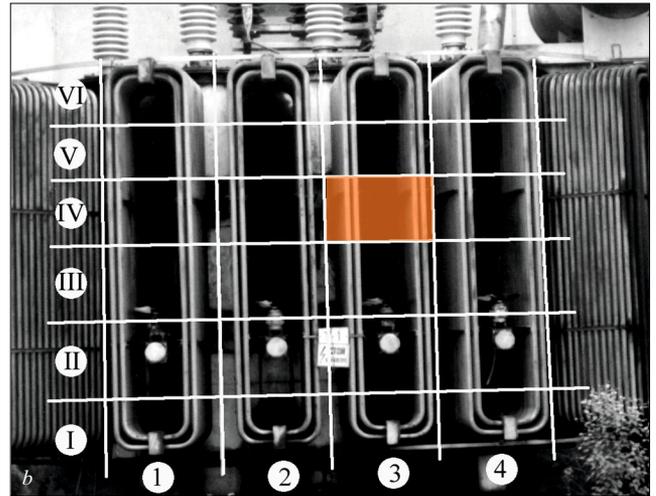
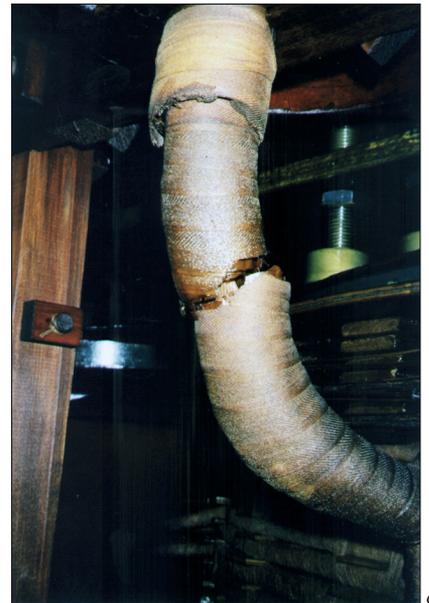
Mechanical damage to the insulation of transformers, as well as sludging, contamination, and moisture, can induce the development of discharge processes. In the TDG-40500/110 transformer, for example, following the replacement of the 110 kV input in the fortieth year of operation, the hydrogen concentration in the oil increased (Fig. 11*a*), reaching 322 ppm in 5 years (at the limit value of 100 ppm). This indicated the development of partial discharges (PD) in the active part. The measurements of PD by an electrical method showed that the level of discharge activity is less than 12 – 15 nC.

When locating discharges on the tank wall, a zone of acoustic activity (marked in yellow in Fig. 11*b*) was detected. The signal occurred at intervals during each half-period of the industrial frequency. The maximum of the amplitude-frequency dependence of the signal reached approximately 80 – 100 kHz, which is characteristic of PD. Upon opening the transformer in the area of acoustic activity, mechanical and thermoelectric damage to the insulation of the B-phase HV lead were detected (Fig. 11*c*); these resulted from a technological disturbance during the installation of a new lead and the development of discharge processes in the damaged area.

Fig. 11. Variations in hydrogen concentration (a), acoustic activity zone (b), and damage to insulation of HV output of phase B (b) of TDG-40500/110 transformer.

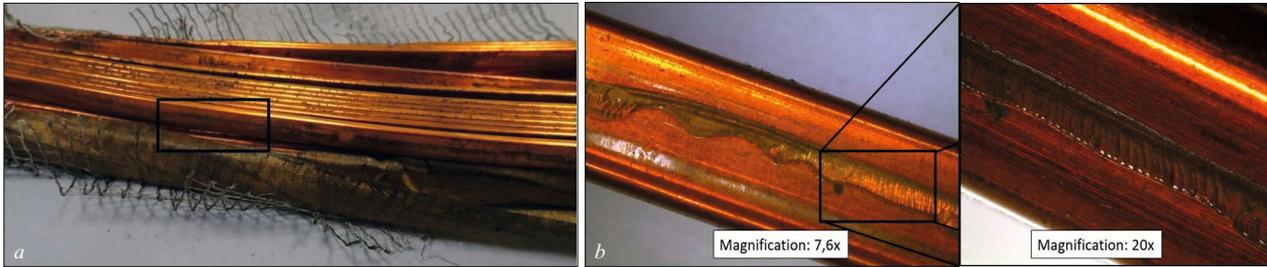
In another case, in the LV winding of a 500 kV transformer, epoxy resin was applied to the elementary conductors in strips, while on some conductors the resin was applied only to a small area with uneven distribution along the length of the elementary conductor (Fig. 12). Along with other factors, this technological violation is identified as having led to internal short circuit and transformer failure. Here it should

be noted that the diagnostic parameters — including DGA and the readings of the monitoring system — indicated no development of dangerous discharge processes or other de-

Fig. 12. A fragment of a 500 kV transformer LV winding wire (a) and zones of single conductors at 7.6 \times and 20 \times magnification (b).

fects. The concentration of hydrogen was less than 11 ppm while that of acetylene was less than 1 ppm (with limit values of 100 ppm and 10 ppm, respectively), with all other diagnostic parameters also remaining significantly lower than the permissible values [1, 2].
