DIAGNOSTIC EXAMINATION OF ISOLATED BUS DUCTS

A. P. Dolin¹

Translated from *Élektricheskie Stantsii*, No. 4, April 2020, pp. 48 – 53.

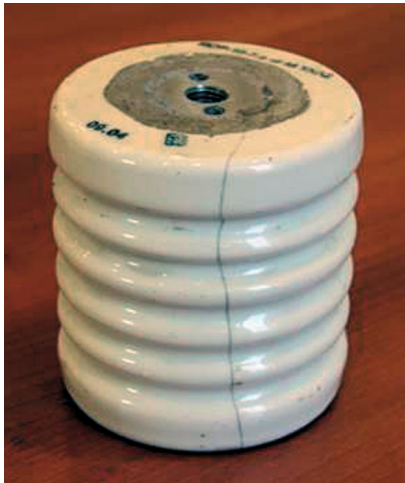
Fig. 3. Damaged insulator.

To gain experience in determining the nature and level of the defects developing inside the isolated bus duct insulators, and to identify the appearance of the defects, a model testing was performed using a bus duct model with an insulator having a crack in a porcelain body (Fig. 3), and with an undamaged insulator having a dry, wet and contaminated surface. Figure 4 shows the schematic diagram of the experimental setup.

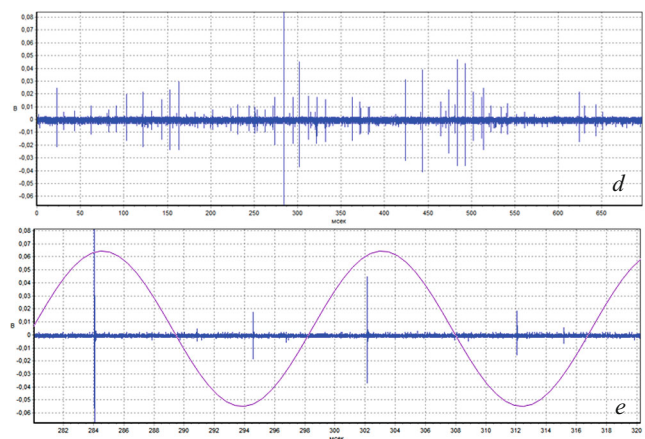
Fig. 5. Oscillograms of electric and acoustic signals from wet and contaminated insulators (no cracks).

The measurement results are illustrated in Fig. 5, which shows the discharge activity oscillograms at 2.5 msec/div (*a*) and 100 nsec/div (*b*); amplitude-phase pulse distributions of signals (accumulation mode) recorded by R400 with electromagnetic sensor (*c*), and acoustic signal obtained by AR200 at 50 msec/div (*d*) and 2 msec/div (*e*). Periodically varying curves shown in Fig. 5*a, c, e*, represent operating voltage.

Both wet and contaminated insulators without cracks demonstrated discharge phenomena that were recorded (Fig. 5*a, b*). Based on the signal processing results obtained using R400, the achieved voltage level was 3.7 V (Fig. 5*c*). The acoustic sensor recorded discharges with prevailing signal levels of 20 – 40 mV. In rare cases, the signal level reached more than 100 mV. The amplitude-frequency characteristic of the acoustic signal (with the maximum amplitude shown in Fig. 5*d, e*) demonstrates a broad spectral band (Fig. 6*a*) having a maximum around 110 – 120 kHz.

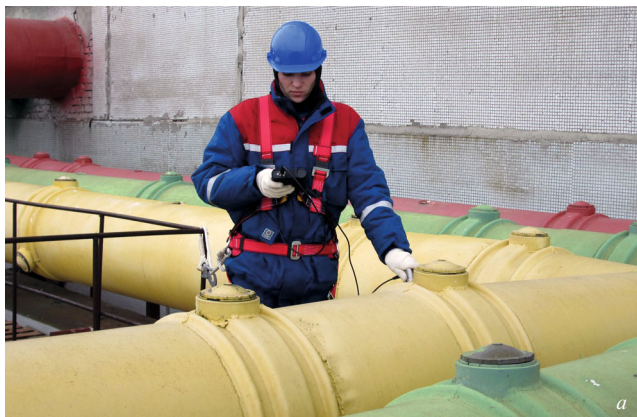
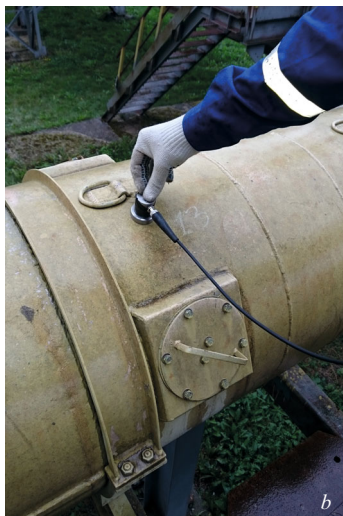
Fig. 7. PD location using electromagnetic (*a*) and acoustic (*b*) sensors during diagnostic examination of isolated bus ducts.

When performing such testing, both acoustic and induction sensors are sequentially installed within each insulator belt (Fig. 7). The recorded signals are processed. In this case, the frequency of signals occurrence, their amplitude, amplitude-frequency and amplitude-phase distributions are analyzed.
