MAJOR DEFECTS AND DIAGNOSTICS OF SOLID INSULATION OF POWER TRANSFORMERS

A. P. Dolin¹ and M. M. Kipriyanova²

Translated from *Élektricheskie Stantsii*, No. 6, June 2022, pp. 27 – 33. DOI: 10.34831/EP.2022.1091.6.004

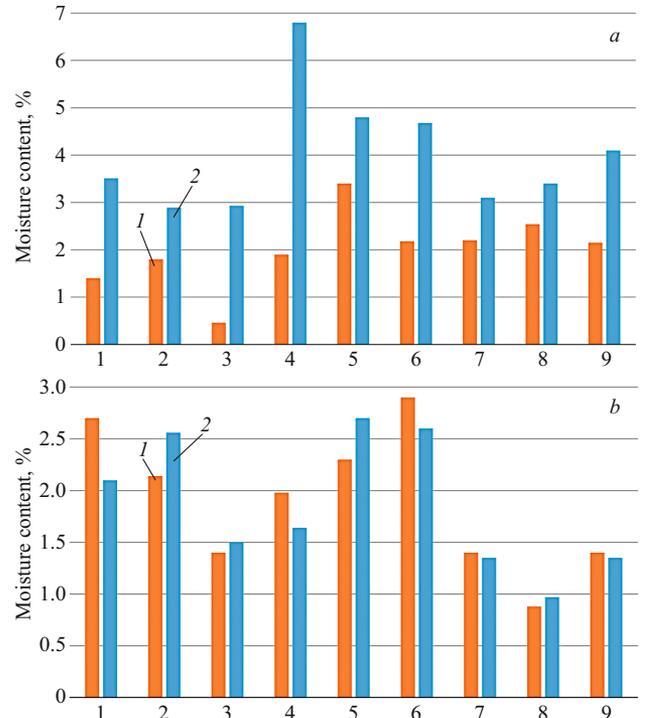
The results of direct measurements of the moisture content of solid insulation (3 mm thick insulating cylinders and barriers, a 0.5 mm thick winding selected at the attachment points of the leads-out) (Fig. 7) were as follows. Transformers having a D cooling system (natural oil circulation) are always characterized by higher moisture content in the cellulose insulation at the bottom of the tank, while transformers having a DC cooling system (forced oil circulation) show only a slight difference in moisture content values between the top and bottom of the tank. Figure 8 depicts the diagrams of the highest recorded moisture content in the selected samples collected from the upper (1) and lower (2) parts of several 110, 150, and 220 kV transformers equipped with D and DC cooling systems. In these diagrams, the conditional numbers of transformers are indicated along the x -axis.

No significant difference in the moisture content of the cellulose insulation of the winding and barriers was observed. The variation of the moisture content of samples having different thicknesses reached 20–40% of the maximum,

Fig. 8. Moisture content of insulation in the upper and lower parts of transformer tank equipped with cooling systems D (*a*) and DC (*b*).

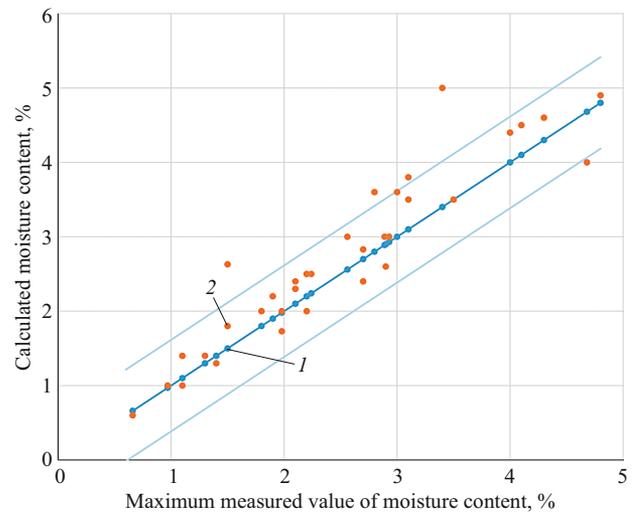
Since the direct determination of the moisture content of cellulose insulation is only possible during overhaul repairs of transformers, this parameter is determined analytically during operation [1, 2]. In the Russian Federation, the method of determining moisture content by dielectric characteristics is most commonly used [5]. The highest moisture contents of cellulose insulation obtained by the method described in the work [5] were compared with those of direct measurements during overhaul repairs of 38 110 and 500 kV transformers having a service life ranging from 14 to 46 years. The characteristic values of the moisture content of the insulation are shown in Fig. 9 (1, highest measured value; 2, calculated value).

In general, irrespective of the type of cooling system (D or DC), the calculated values for the moisture content of the solid insulation were in close agreement with the highest actual measurement results (deviations of calculated values were within $\pm 12\%$ of the measured result). In two cases, the calculated values exceeded the measured values by

Fig. 9. Comparison of maximum measured and calculated values of moisture content.

30 – 40%. However, in these transformers, high values of the dissipation factor of oil (5.9 and 18.2%) were recorded.
