Scientific Colloquium on High Voltage Engineering

THE FAILURE RATE AND PROCEDURES OF INSPECTION OF POWER TRANSFORMERS IN RUSSIA

NEW TRANSFORMER REPAIR TECHNOLOGY OF WASHING WITH OIL CONTAINING SPECIAL ADDITIVES

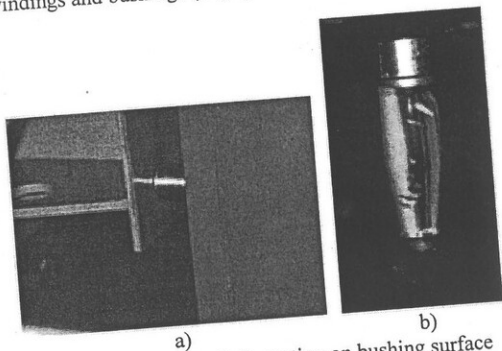
Fig. 2. Carbon deposit formation on bushing surface
a - spark discharges point in the area of the transportation bolt; b - carbon covered porcelain cap of the bushing located above the discharge area.

4. Faulted loops which are often found in magnetic system structural elements lead to over heating, increased gas emission and formation of carbon at spark and arc discharges. Carbon spreading beyond the arc burning area can result in semiconducting deposit formation on the insulation of both windings and bushings (Fig.2) and in creation of conditions for flash-overs.

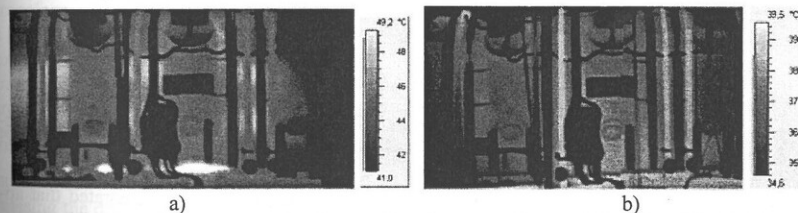
Fig. 3. Infra-red imager examination results of autotransformer 250 MVA 330/150 kV under load (a) and under no-load (b) modes of operation

A number of inspections listed in table 2 are performed for two modes of transformer operation: no load and maximum load. The defects related to the formation of faulted loops in magnetic system can be diagnosed best of all namely by comparison of the results obtained for the various modes of transformer operation. Efficiency of such a comparison can be illustrated on an example of infra-red imaging of autotransformer 250 MVA 330/150 kV .

It is seen in fig.3 that temperatures registered by infra-red (IR) imager of the lower parts at the tank were essentially higher in the case of on-loaded transformer than in the case of no-load operation mode. After the transformer opening up yoke beam contact to frame was revealed. The chromatographic analysis of this transformer showed only inconsiderable (52-67 ppm) increase of ethane (C₂H₆) concentration in comparison with its allowable level (50 ppm). The above mentioned defect could not be revealed by the other means: e.g. acoustic, partial discharges, vibration, etc.

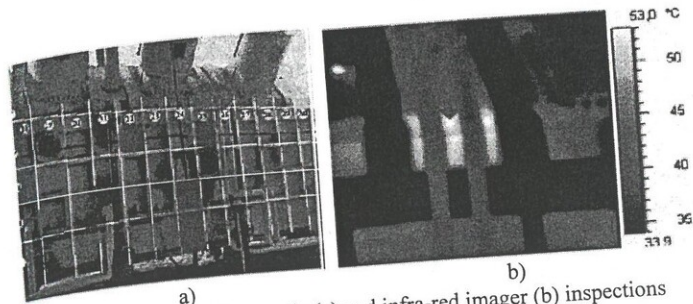
Fig. 4. Results of acoustic (a) and infra-red imager (b) inspections of step-up transformer 360 MVA 220 kV

But in some other cases these and some other inspection methods were adequate enough. It may be demonstrate by the example of inspection of step-up 360 MVA 220 kV transformer . An increased gas concentration was fixed in this transformer and it was assumed that a high temperature overheating affecting the rigid insulation took place there The PD measurements revealed some pulses which were identified as discharges in the magnetic system. Acoustic examination showed the availability of areas of an increased acoustic activity, including ones created by the sources with signal frequency of 30-40 kHz (marked with yellow colour in fig. 4, a). The overheated areas were revealed by IR-imager inspection (fig. 4, b).

Diagnosis: loss of tie studs insulation. After the transformer opening up it was found out that 5 tie studs had zero insulation relatively to the magnetic core.
